Coastal Protection and Restoration Authority of Louisiana (CPRA)

2016/2017 Annual Inspection Report

EAST MARSH ISLAND MARSH CREATION PROJECT (TV-21)

May 16, 2017 Iberia Parish

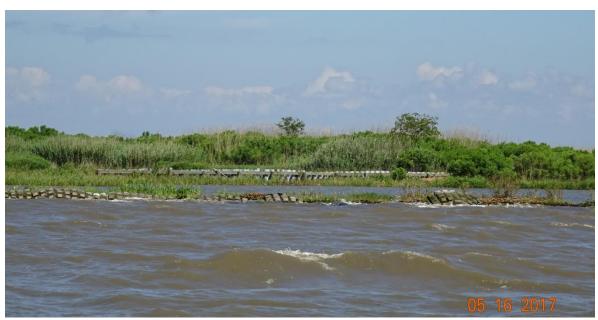
The remaining containment dike is at an average elevation of +3.37ft NAVD88 with 15 gaps to allow tidal exchange. Vegetation has expanded on the dikes which negated the need to plant. The concrete articulated mats placed in March 2015 on the Northeast corner of the island in MC Cell No. 1 at the East-West Pipeline Canal has settled significantly at the original breach location. However, it continues to break the wave action approaching the shoreline. In addition, from survey information the borrow channel on the interior of the containment dike which was excavated to repair the breach has silted in to -2.5ft NAVD88.

The 2015 maintenance performed to address the breaches near the East-West Canal has experienced settling due to the soil quality and site conditions during construction. It however is still protecting the area of concern.

Photo No. 1, MC Cell No. 1 - Articulated Concrete Mat (2015 Maintenance Event)

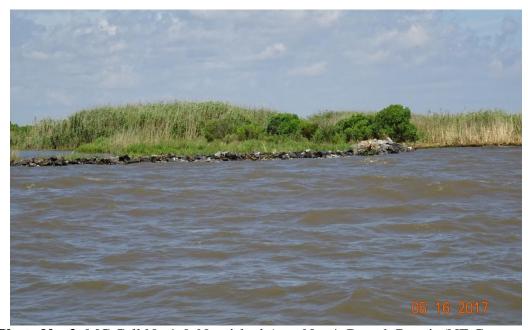
During the Year 5 Survey, point shots were collected within the Nourished Areas. According to the Survey, Nourished Area No.1 has seen minor settlement. Nourished Area No. 2, is showing a positive elevation trend ranging from a 1 in. to a 7in. increase. Nourished Areas No. 3 & 4 are stable with little change.

(Photos: Appendix B, Photo 2)

Photo No. 2, MC Cell No.1 & Nourished Area No. 4, Breach Repair (NE Corner of Island at East End of E-W Pipeline Canal (2015 Maintenance Event)

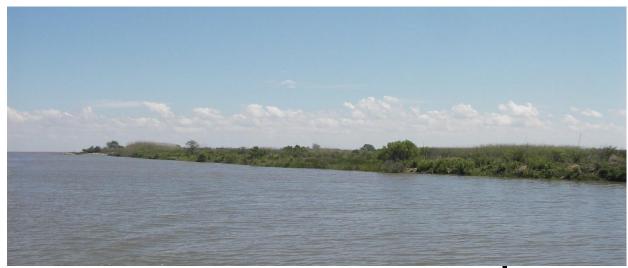
Photo No. 3, MC Cell No. 1, North South Canal Looking North

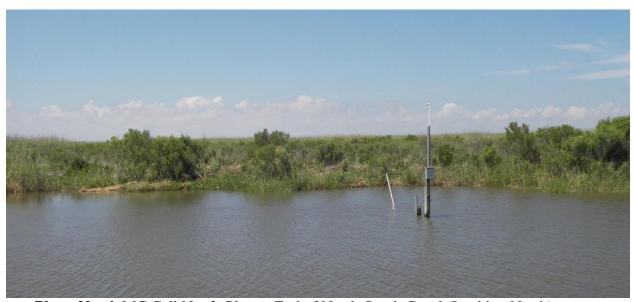
The earthen plug at the end of the North-South Pipeline Canal was intact. (Photos: Appendix B, Photo No. 4)

Photo No. 4, MC Cell No. 2, Plug at End of North-South Canal (Looking North)

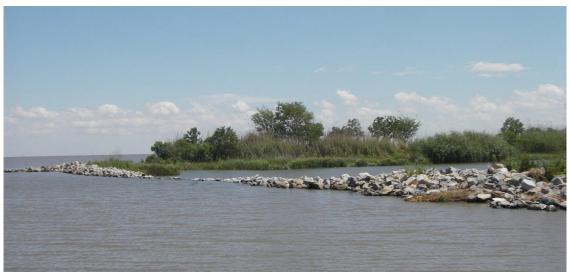
Photo No. 5, Nourished Area No. 4, Plug (TV-14 Project- End of East West Canal Looking North)

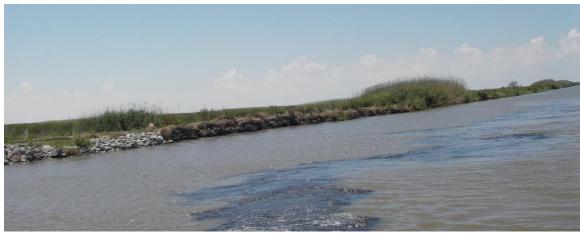
Photo No. 6, MC Cell No. 1, Plug Tie-In (TV-14 Project- End of East West Canal - Looking SouthEast)
